**QF/PQM-102 TARGET SYSTEM,
PROJECT PAVE DEUCE**

PQM-102 SYSTEM PROGRAM OFFICE

FINAL REPORT: MARCH 1973 - APRIL 1975

**DEPUTY FOR ARMAMENT SYSTEMS
ARMAMENT DEVELOPMENT AND TEST CENTER**

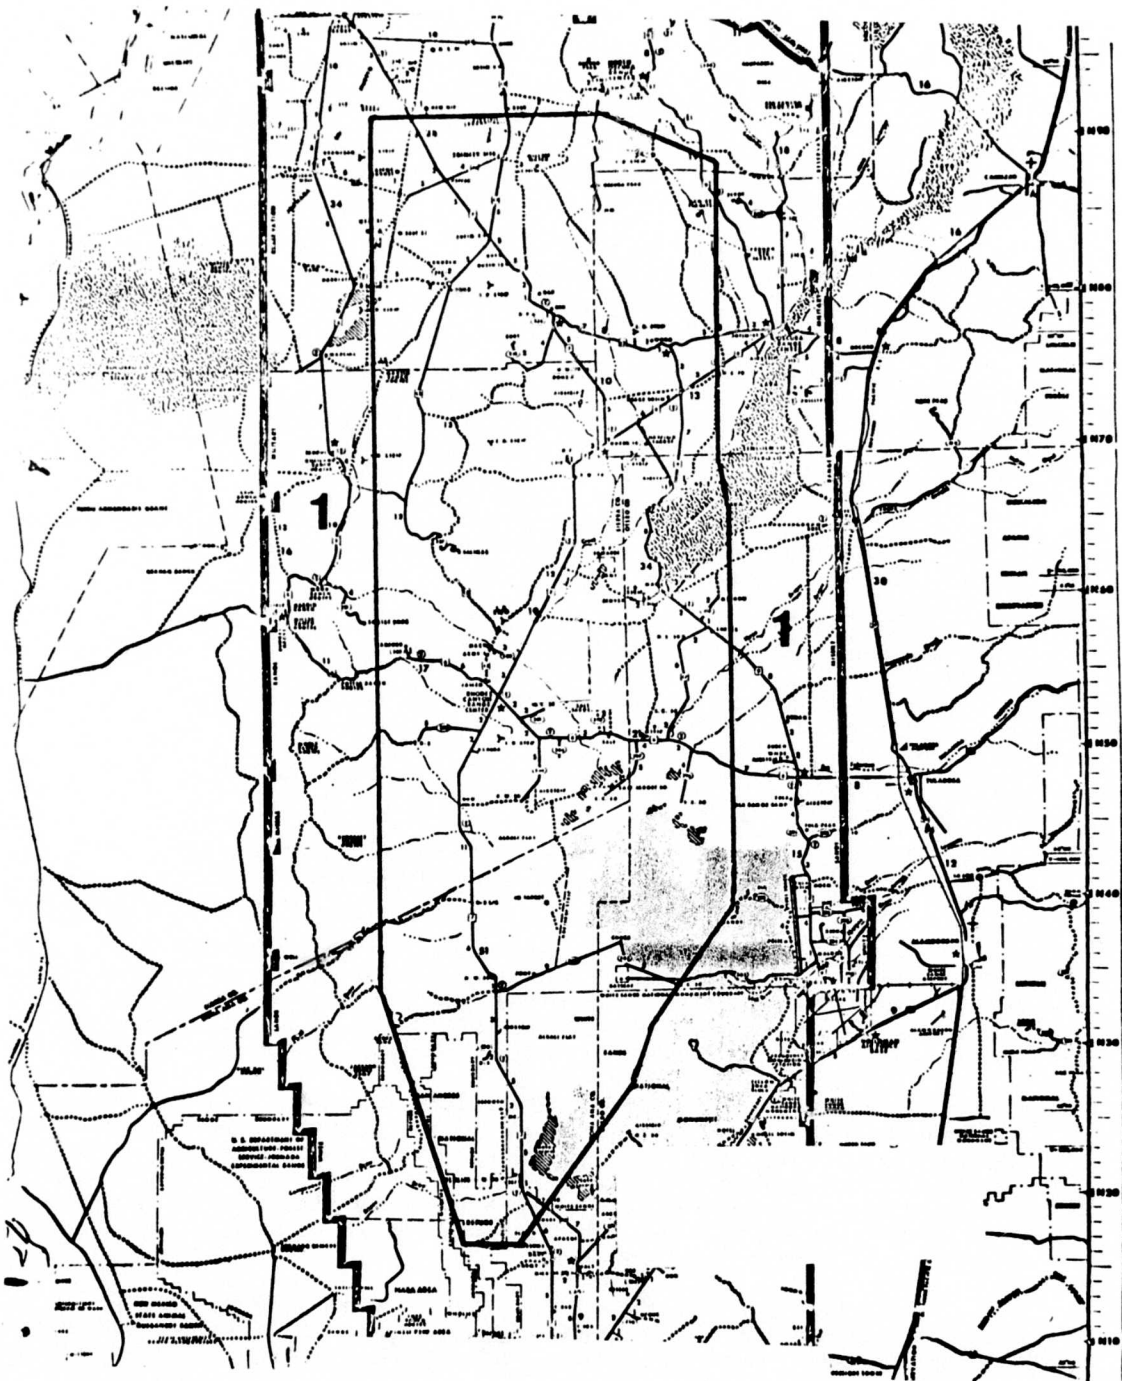
Figure 47. PQM-102 Safety Boundary with Timer Settings of 10 Seconds, Altitude of 20,000 Feet, and Velocity of 625 KTAS
